NASA TM X-1721

ROCKET ENGINE EVALUATION OF EROSION AND CHAR AS FUNCTIONS OF FABRIC ORIENTATION FOR SILICA-REINFORCED NOZZLE MATERIALS

by Donald A. Peterson, Jerry M. Winter,
and Arthur M. Shinn, Jr.

Lewis Research Center
Cleveland, Ohio

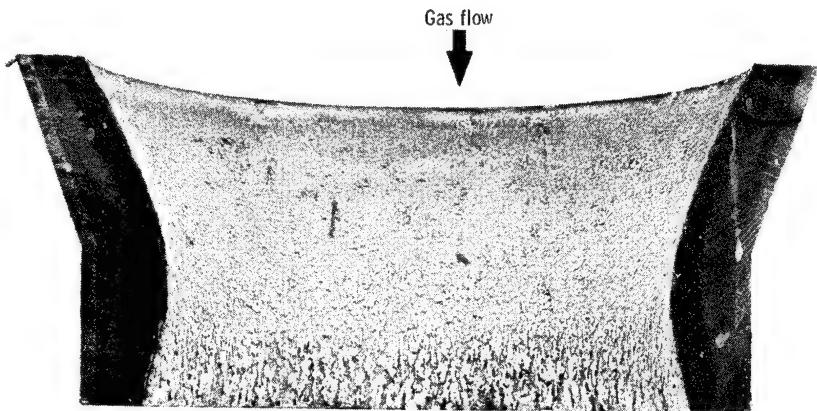
(a) Nozzle 1A; orientation, 30° centerline; 70-percent silicon dioxide - 30-percent phenolic.

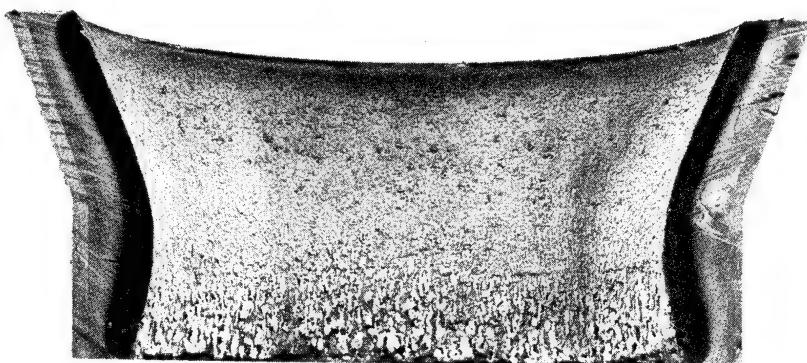
(b) Nozzle 1B; orientation, 60° centerline; 70-percent silicon dioxide - 30-percent phenolic.

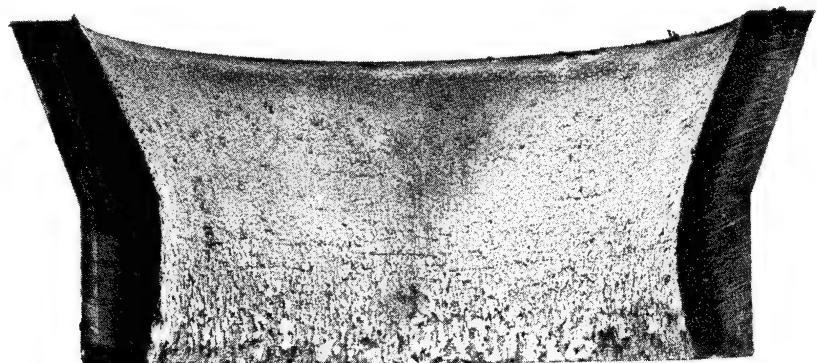
(c) Nozzle 1C; orientation, 90° centerline; 70-percent silicon dioxide - 30-percent phenolic.

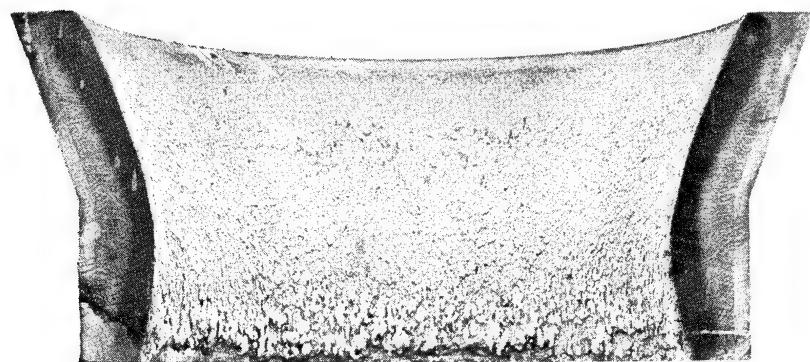
(d) Nozzle 1D; orientation, 1/2 by 1/2 square; 70-percent silicon dioxide - 30-percent phenolic.

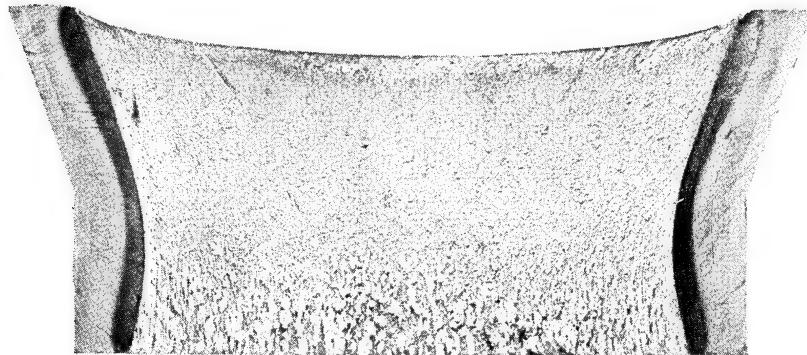
(e) Nozzle 1E; orientation, rosette; 70-percent silicon dioxide - 30-percent phenolic.

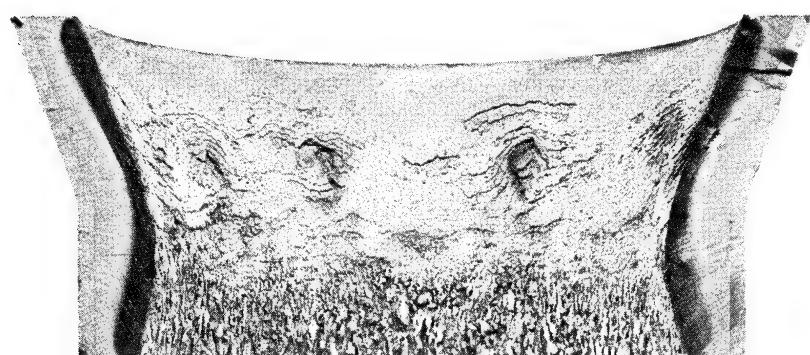
(f) Nozzle 2A; orientation, 30° centerline; 61-percent silicon dioxide - 31-percent phenolic - 8-percent silicon dioxide filler.

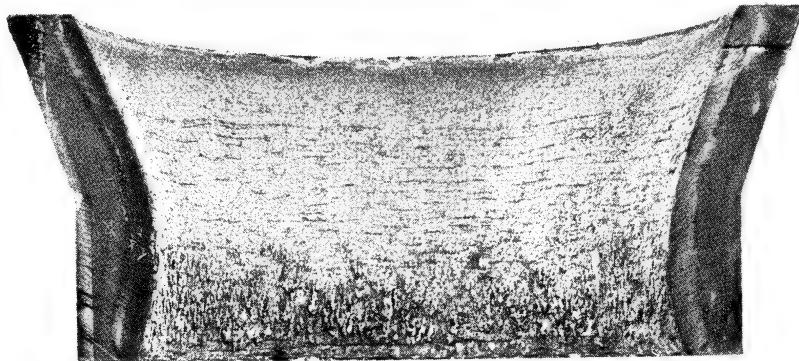
(g) Nozzle 2B; orientation 60° centerline; 61-percent silicon dioxide - 31-percent phenolic - 8-percent silicon dioxide filler.

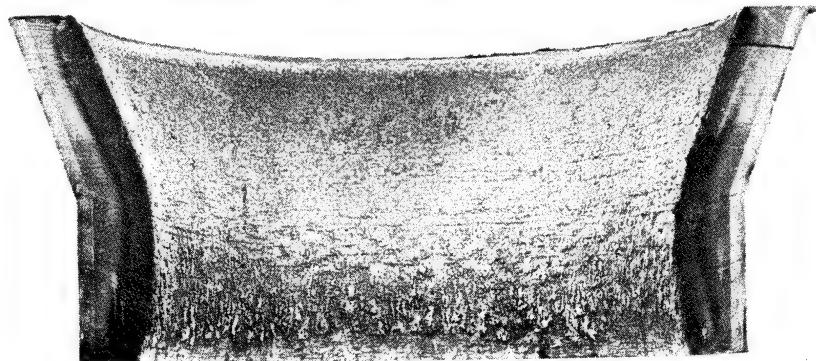
(h) Nozzle 2C; orientation 90° centerline; 61-percent silicon dioxide - 31-percent phenolic - 8-percent silicon dioxide filler.

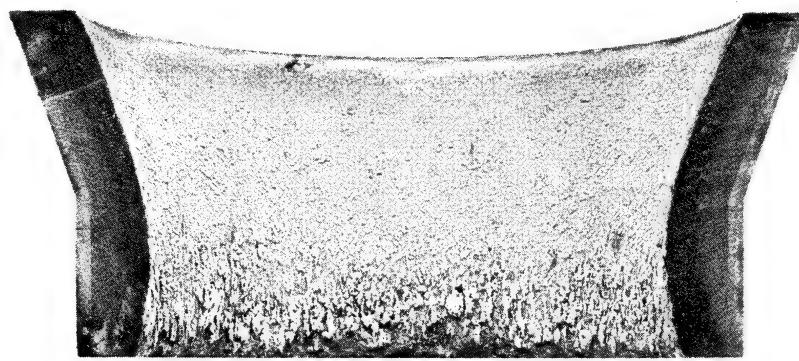
(i) Nozzle 2D; orientation, 1/2 by 1/2 square; 61-percent silicon dioxide - 31-percent phenolic - 8-percent silicon dioxide filler.

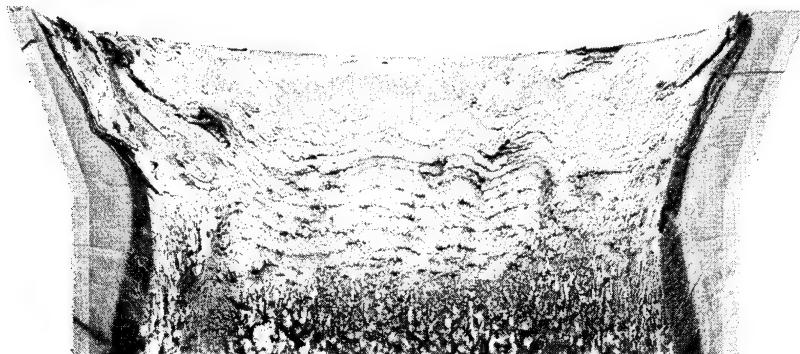
The results for material number 3, a 32-percent phenolic-polyamide resin with high-silica reinforcement, presented in figure 8(c), are similar to those of material 2. The 30° and 60° orientations were superior in erosion resistance to the 90° and random square orientation. The nozzle with 30° orientation was also delaminated upstream of the throat (see fig. 6(j)).

(j) Nozzle 3A; orientation, 30° centerline; 68-percent silicon dioxide - 32-percent phenolic polyamide.

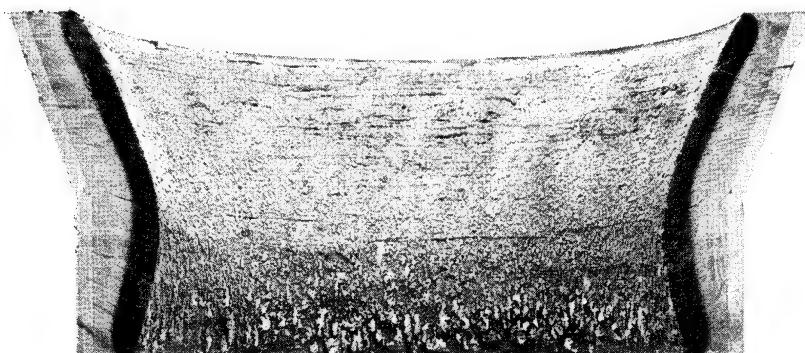
(k) Nozzle 3B; orientation, 60° centerline; 68-percent silicon dioxide - 32-percent phenolic polyamide.

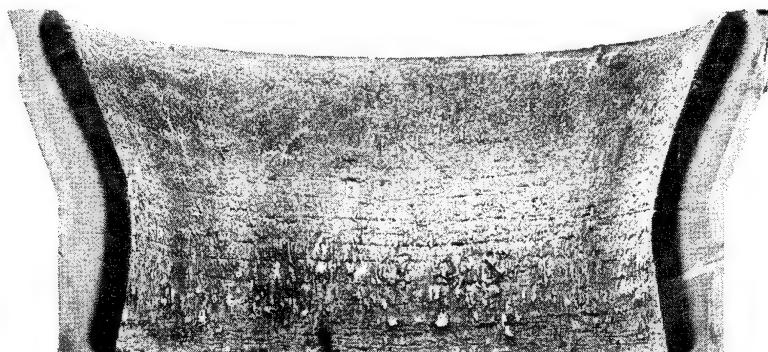
(l) Nozzle 3C; orientation, 90° centerline; 68-percent silicon dioxide - 32-percent phenolic polyamide.

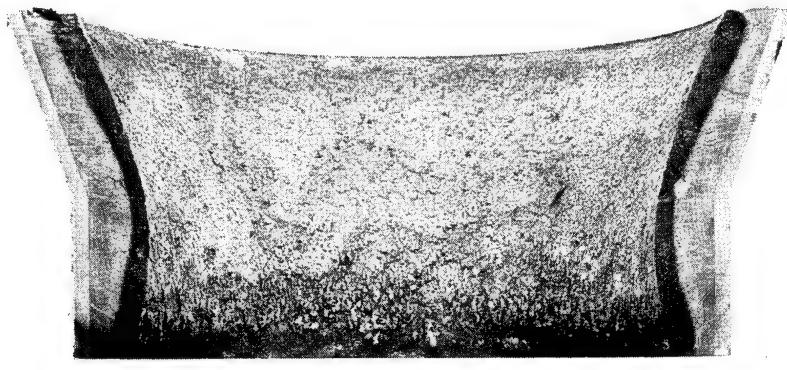
(m) Nozzle 3D; orientation, 1/2 by 1/2 square; 68-percent silicon dioxide - 32-percent phenolic polyamide.

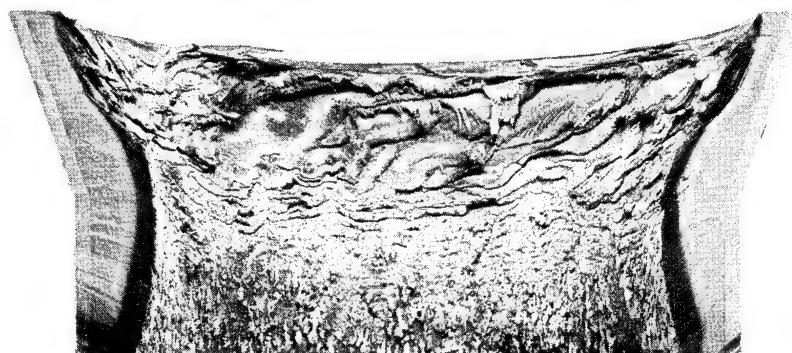
(n) Nozzle 4A; orientation, 30° centerline; 80-percent silicon dioxide - 20-percent phenolic polyamide.

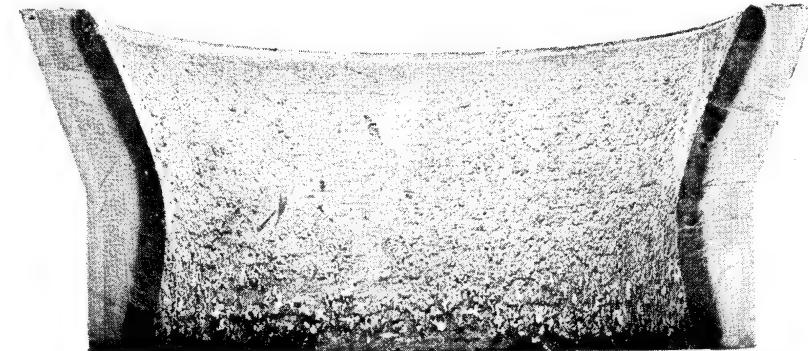
(o) Nozzle 4B; orientation, 60° centerline; 80-percent silicon dioxide - 20-percent phenolic polyamide.

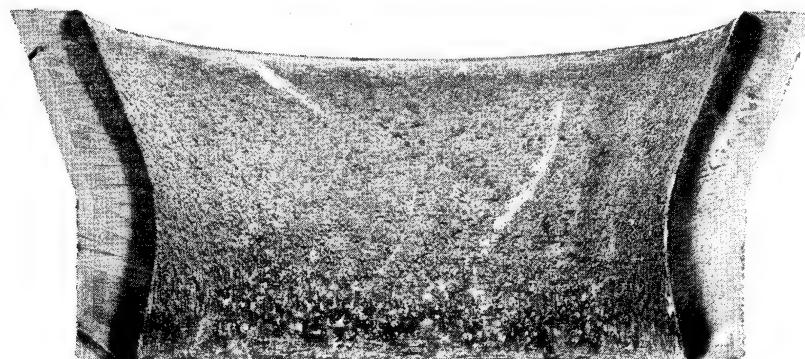
(p) Nozzle 4C; orientation, 90° centerline; 80-percent silicon dioxide - 20-percent phenolic polyamide.

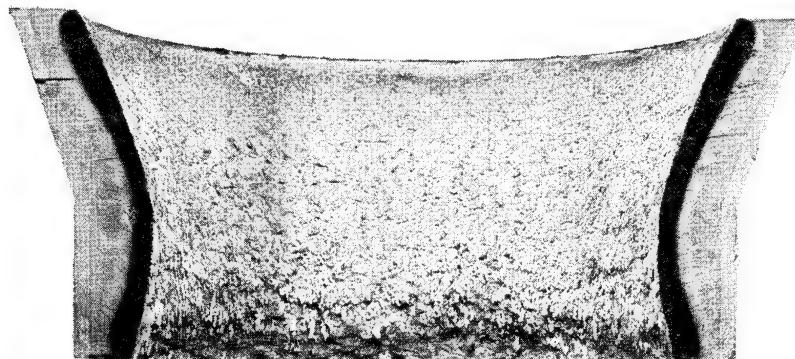
(q) Nozzle 4D; orientation, 1/2 by 1/2 square; 80-percent silicon dioxide - 20-percent phenolic polyamide.

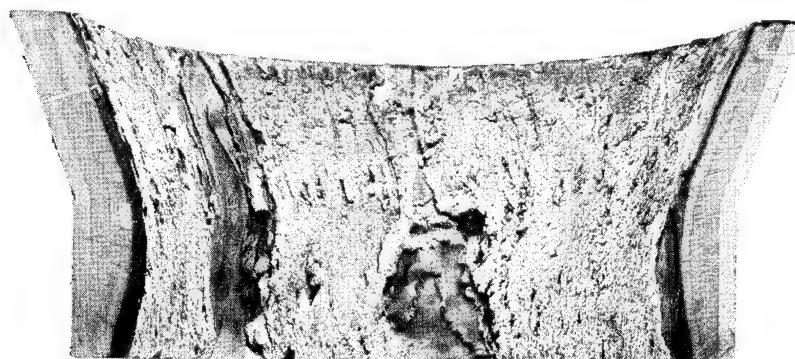
Number 4 material, 20-percent phenolic-polyamide high silica, had fairly uniform erosion results for all of the orientations except the rosette layup which eroded 50-percent more than the other orientations for the same firing duration. The 30° and rosette orientations were also severely delaminated. Material 4a delaminated upstream only while 4e delaminated in the throat region. Figure 8(d) shows the firing results and figures 6(n) and 6(r) are the post-firing photographs which show the fabric delaminations.

(r) Nozzle 4E; orientation, rosette; 80-percent silicon dioxide - 20-percent phenolic polyamide.

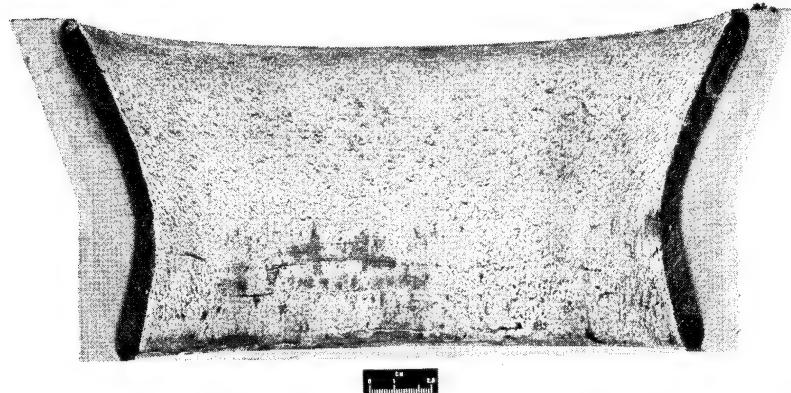
(s) Nozzle 5A; orientation, 30° centerline; 67-percent silicon dioxide - 3 percent chrome salt - 30-percent phenolic.

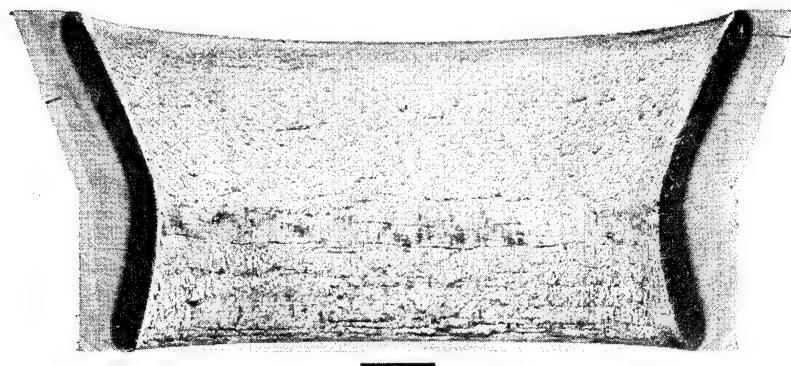
(t) Nozzle 5B; orientation, 60° centerline; 67-percent silicon dioxide - 3-percent chrome salt - 30-percent phenolic.

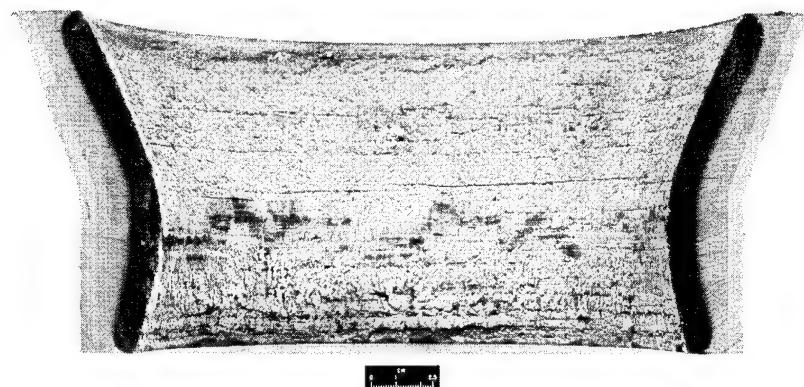
(u) Nozzle 5C; orientation, 90° centerline; 67-percent silicon dioxide - 3-percent chrome salt - 30-percent phenolic.

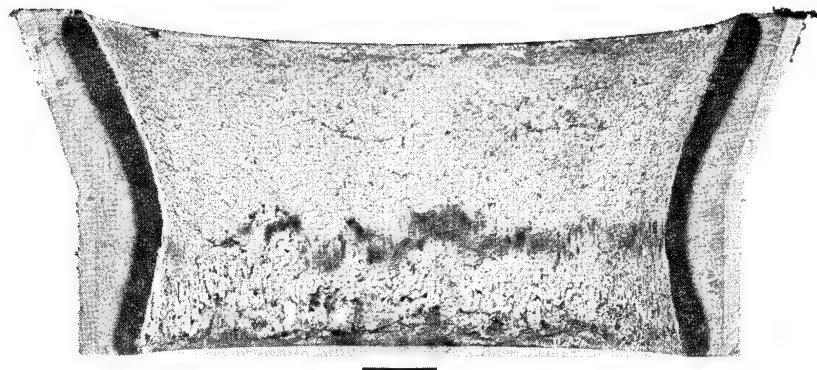
(v) Nozzle 5D; orientation, 1/2 by 1/2 square; 67-percent silicon dioxide - 3-percent chrome salt - 30-percent phenolic.

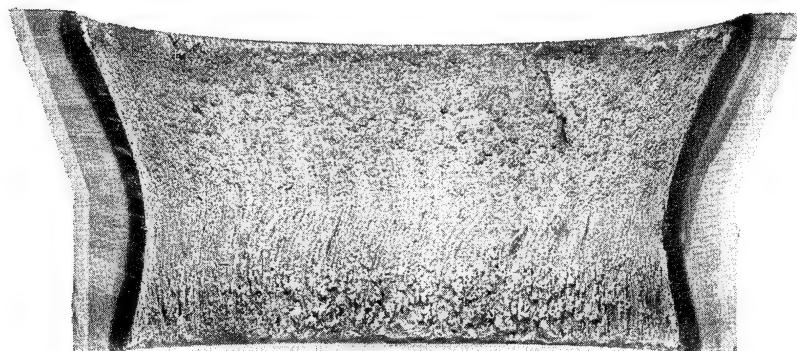
(w) Nozzle 5E; orientation, rosette; 67-percent silicon dioxide - 3-percent chrome salt - 30-percent phenolic.

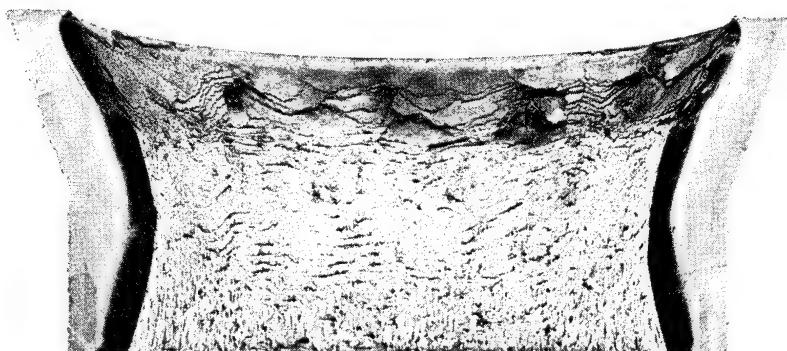
Figure 8(f) shows the erosion of material 6, a 30-percent modified phenolic with high-silica reinforcement. The 60° fabric orientation had slightly better erosion resistance when compared to all of the other fabric orientations. The 30° layup angle material exhibited severe upstream delamination (fig. 6(x)).

(x) Nozzle 6A; orientation, 30° centerline; 70-percent silicon dioxide - 30-percent modified phenolic.

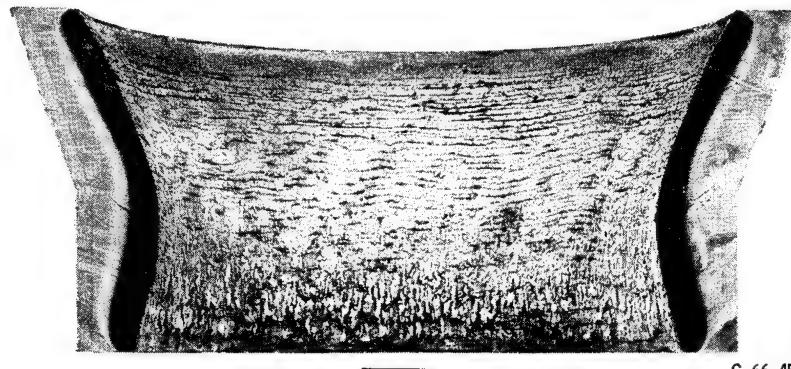
(y) Nozzle 6B; orientation 60° centerline; 70-percent silicon dioxide - 30-percent modified phenolic.

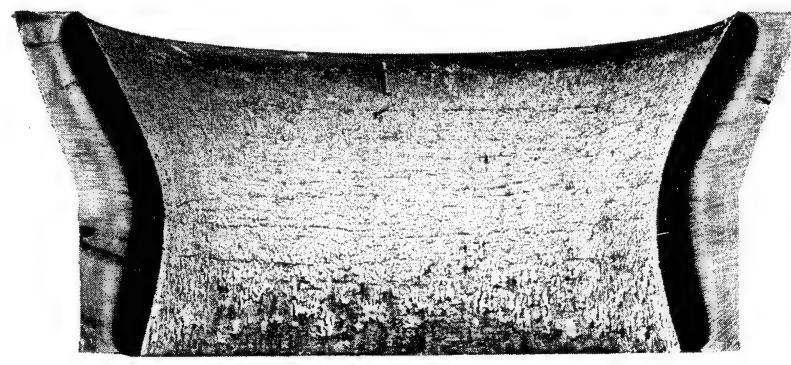
(z) Nozzle 6C; orientation, 90° centerline; 70-percent silicon dioxide - 30-percent modified phenolic.

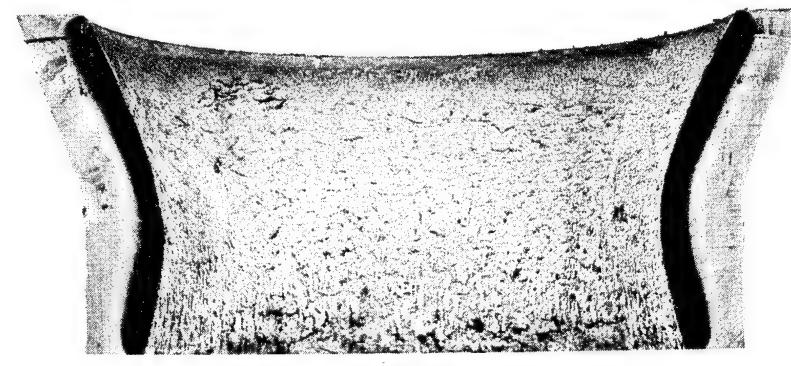
(aa) Nozzle 6D; orientation, 1/2 by 1/2 square; 70-percent silicon dioxide - 30-percent modified phenolic.

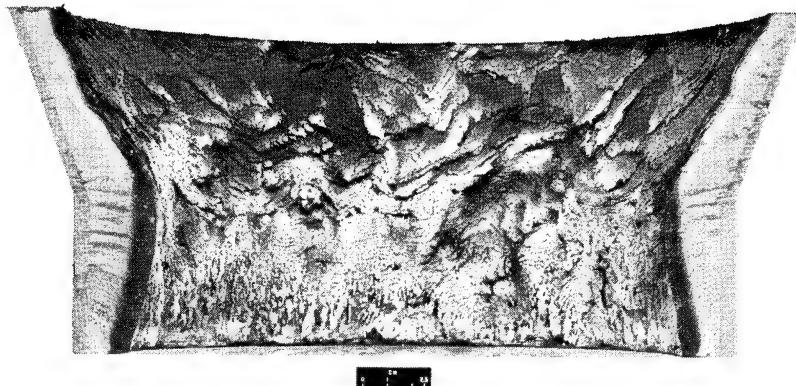
(bb) Nozzle 7A; orientation, 30° centerline; 60-percent silicon dioxide - 40-percent elastomeric phenyl silane.

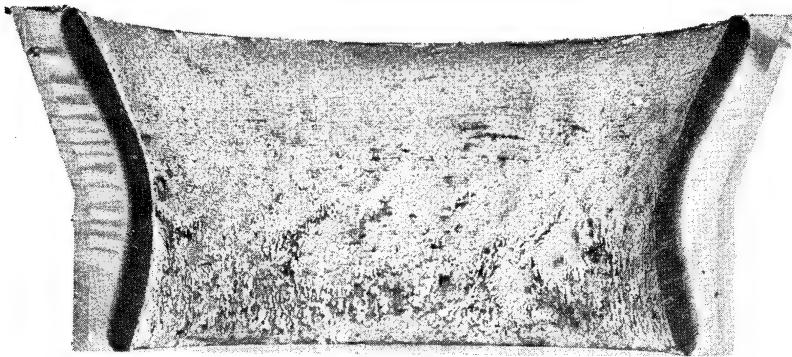
(cc) Nozzle 7B; orientation, 60° centerline; 60-percent silicon dioxide - 40-percent elastomeric phenyl silane.

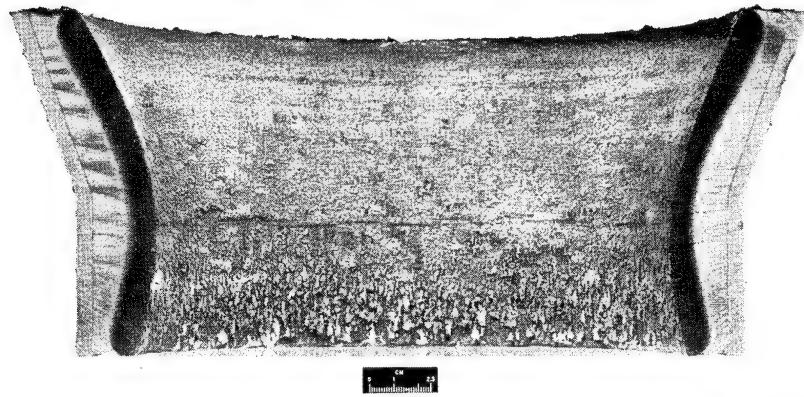
(dd) Nozzle 7C; orientation, 90° centerline; 60-percent silicon dioxide - 40-percent elastomeric phenyl silane.

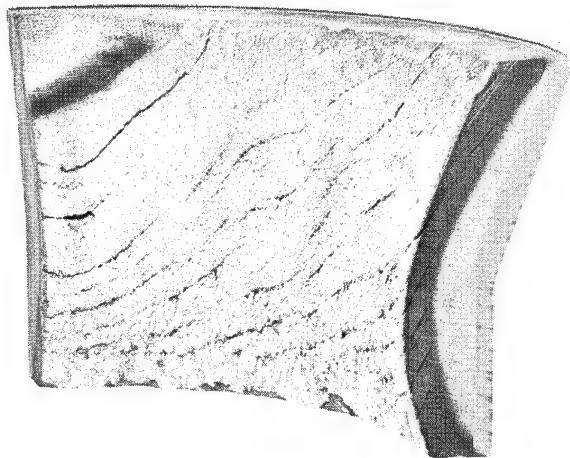
(ee). A possible cause of the high erosion of all rosette layups may be illustrated by comparing the rosette layup used in reference 1 to the rosette layup used here. A helix angle of approximately 20° is illustrated in figure 6(ee), above. Figure 6(ee), below, shows a helix angle near 0° for nozzle 7E. This was typical of all the rosette nozzles. The lack of helix angle also caused the delamination problems experienced with nozzles 4E and 7E.

Rosette orientation from ref. 1.

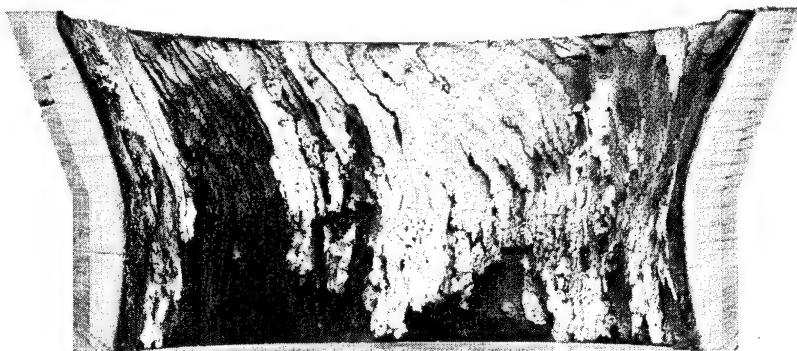
Material 7 was a high silica reinforcement containing 40-percent phenyl-silane resin and elastomer. The 30° and rosette orientations were severely delaminated. The 30° and 60° fabric orientations both were superior in erosion resistance of the four orientations tested (see fig. 8(g)). The rosette layup had more than 100 percent greater erosion than the 30° or 60° orientations. Post-test photographs may be seen in figures 6(bb) to

(ee) Nozzle 7E; orientation, rosette; 60-percent silicon dioxide - 40-percent elastomeric phenyl silane.

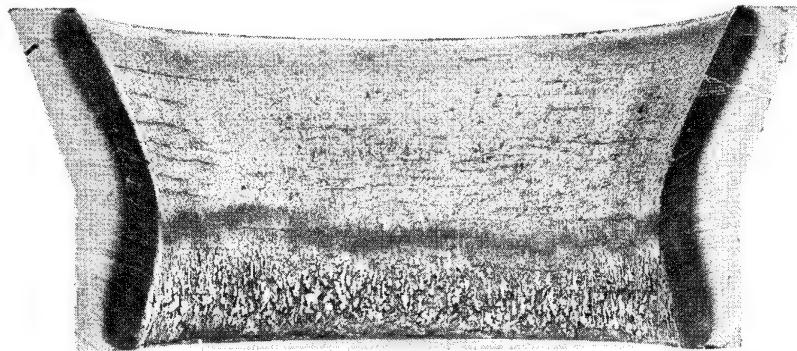
(ff) Nozzle 8B; orientation, 60° centerline; 70-percent silicon dioxide - 30-percent high-temperature phenolic.

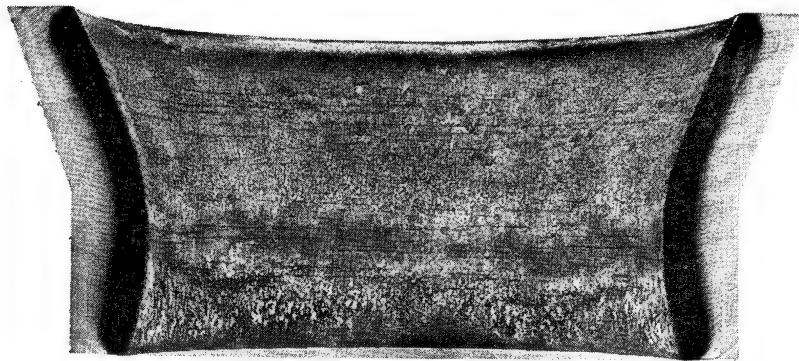
(gg) Nozzle 8C; orientation, 90° centerline; 70-percent silicon dioxide - 30-percent high-temperature phenolic.

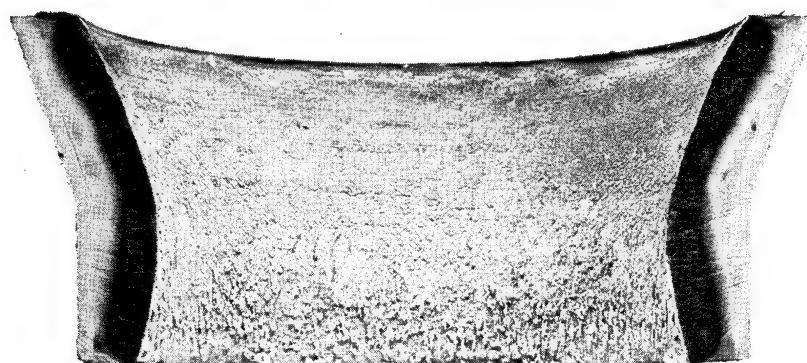
(hh) Nozzle 9C; orientation, 90° centerline; 70-percent silicon dioxide (quartz) - 30-percent polyimide.

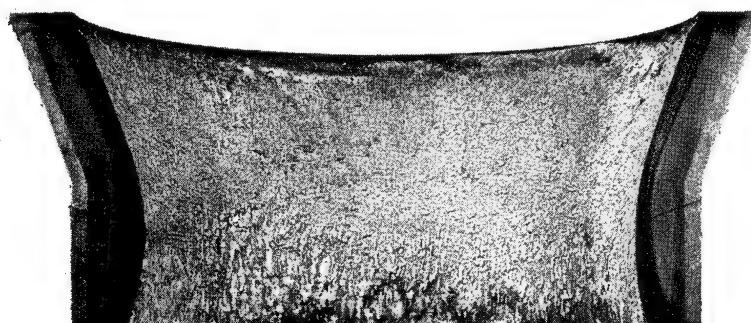
(ii) Nozzle 10E; orientation, rosette; 70-percent silicon dioxide (quartz) - 30-percent phenolic.

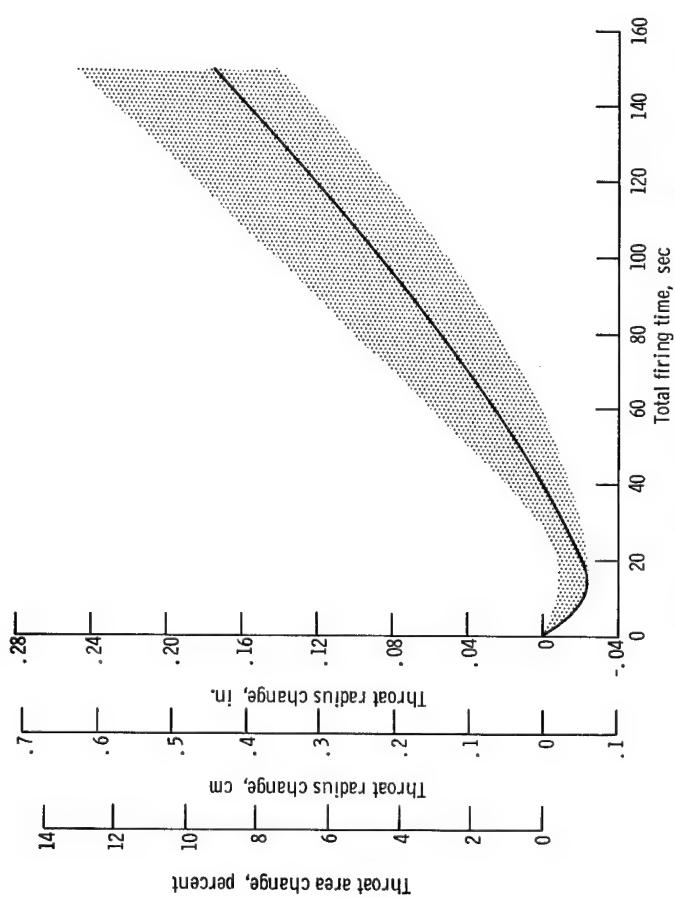
A typical erosion curve is shown on figure 7 along with the data spread for all the nozzles tested except those which delaminated. The shape of the curve indicates steady-state erosion has been attained. A significant increase in slope would be expected when the material is completely charred. Therefore, care must be exercised in extrapolating these data.

Figure 7. - Typical throat erosion curve. Nozzle 6B; orientation, 60° centerline; material, 70-percent silicon dioxide - 30-percent modified phenolic. Crosshatched area shows data spread for all nozzles tested except those that delaminated.

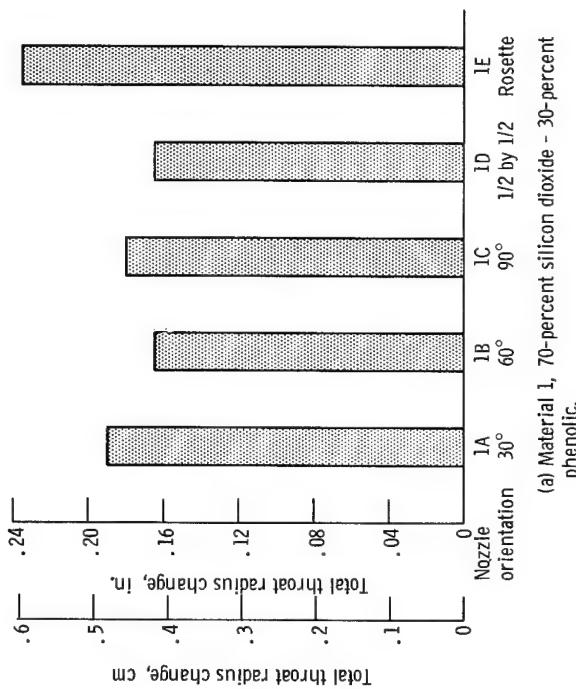
The erosion data for material number 1, 30-percent phenolic high silica, are presented in figure 8(a). Five fabric orientations were evaluated. With the exception of the rosette layup, all of the fabric orientations gave comparable results. (The possible reasons for the relatively poor erosion resistance of all the rosette nozzles will be discussed later in this section.) However, a slight advantage was noted for the 60° and random square orientations.

(a) Material 1, 70-percent silicon dioxide - 30-percent phenolic.

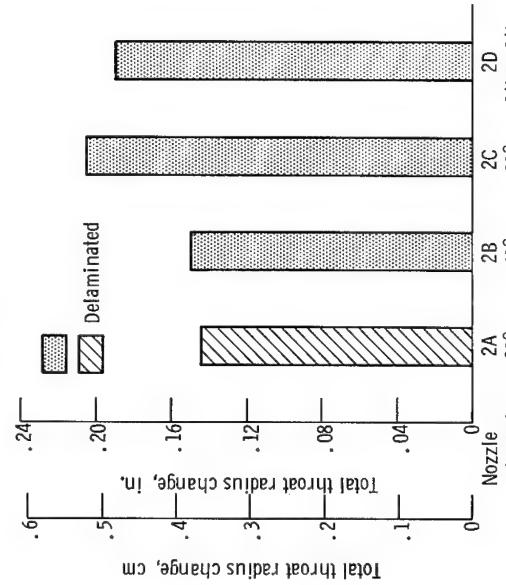
Figure 8(b) shows the results for material number 2. This material is a 31-percent phenolic high-silica material which contains 8-percent silica powder as a filler. The 30° and 60° orientations were superior in erosion resistance when compared to the 90° and random square orientations. The nozzle with 30° orientation was delaminated upstream of the throat, but did not extend to the throat (see fig. 6(f)). This may have affected the throat erosion, possibly by changing the aerodynamic characteristics of the throat.

(b) Material 2, 61-percent silicon dioxide - 31-percent phenolic - 8-percent silicon dioxide filler.

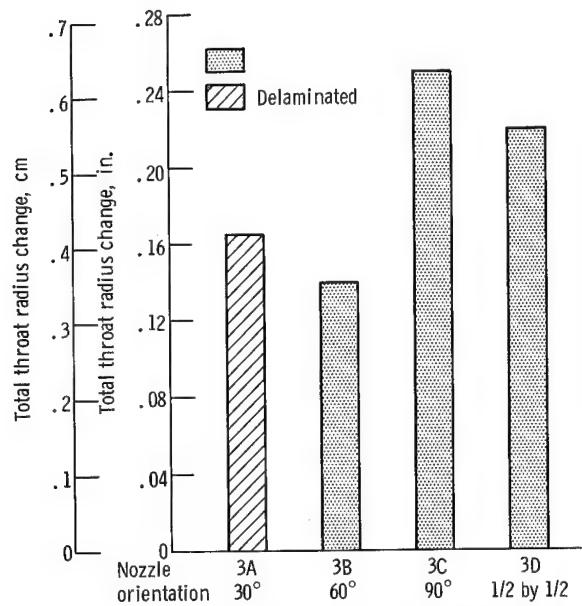
(c) Material 3, 68-percent silicon dioxide - 32-percent phenolic polyamide.

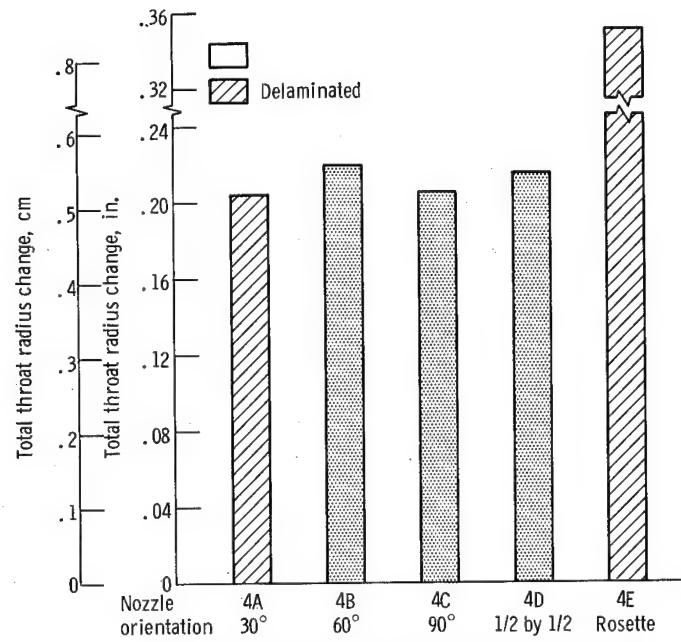
(d) Material 4, 80-percent silicon dioxide - 20-percent phenolic polyamide.

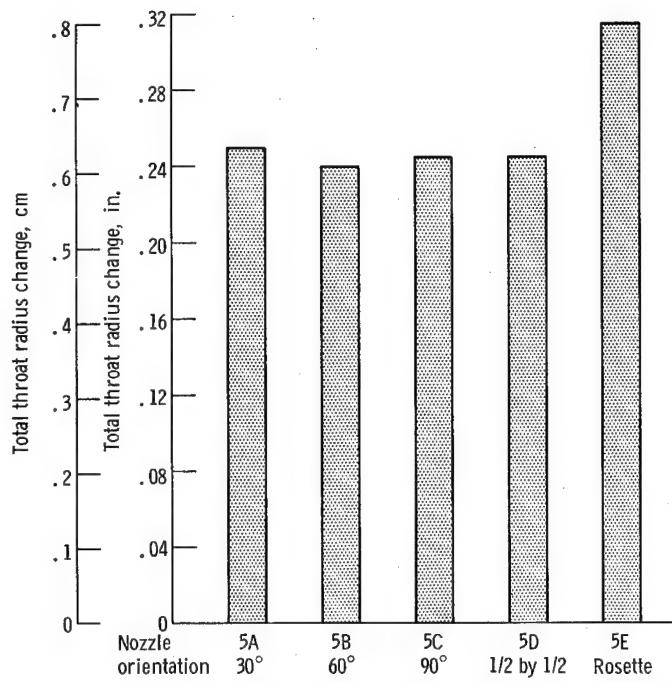
Material 5 was a 30-percent phenolic with high-silica - 3-percent chrome salt reinforcement. Figure 8(e) presents the firing results for all the orientations. The erosion was about the same for all layup angles with the exception of the rosette which exhibited considerably less erosion resistance.

(e) Material 5, 67-percent silicon dioxide - 3-percent chrome salt - 30-percent phenolic.

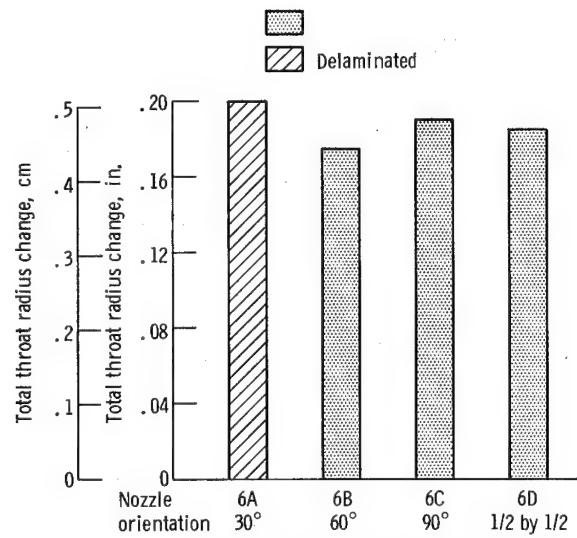
(f) Material 6, 70-percent silicon dioxide - 30-percent modified phenolic.

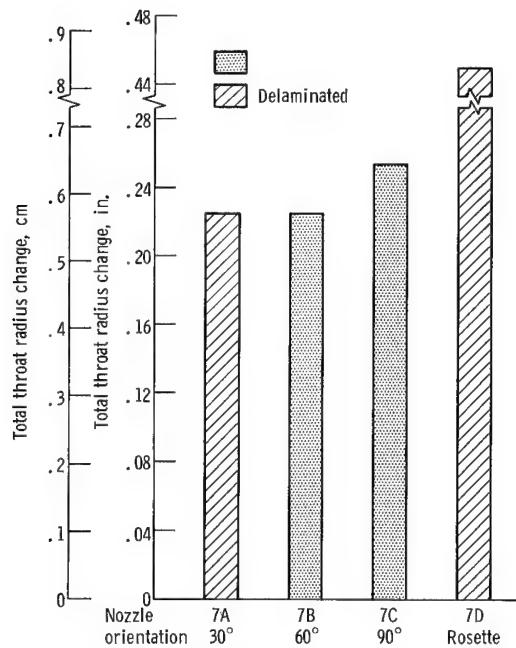
(g) Material 7, 60-percent silicon dioxide - 40-percent elastomeric phenyl silane.

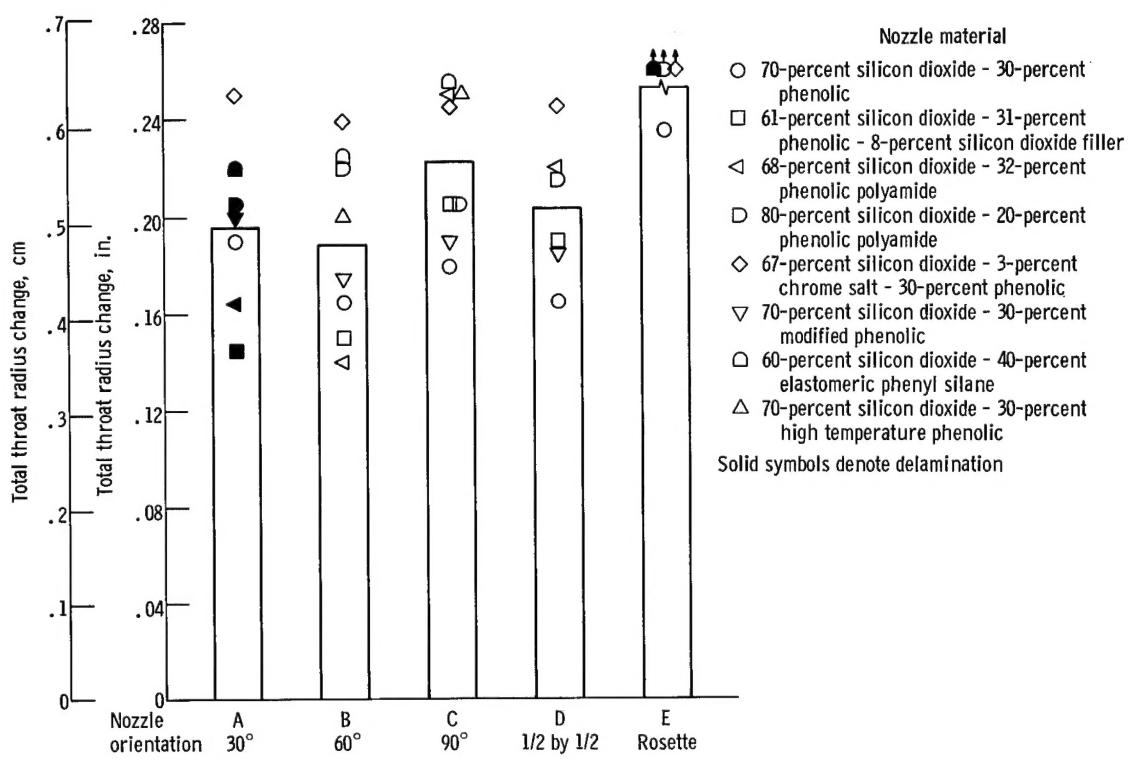
Figure 9. - Average erosion of nozzle materials as function of fabric orientation.

Figure 9 shows the relative trends for each layup angle. The bar graph represents the average of all materials tested. The total erosion of all the nozzles tested is shown, except the quartz-reinforced nozzles. The greatest resistance to throat erosion was measured with the 60° centerline orientation. Results for a 30° centerline orientation were relatively good but may have been influenced by delamination and loss of material upstream of the nozzle throat. A fabric orientation slightly higher than 30° is required when the nozzle approach angle is 30° .

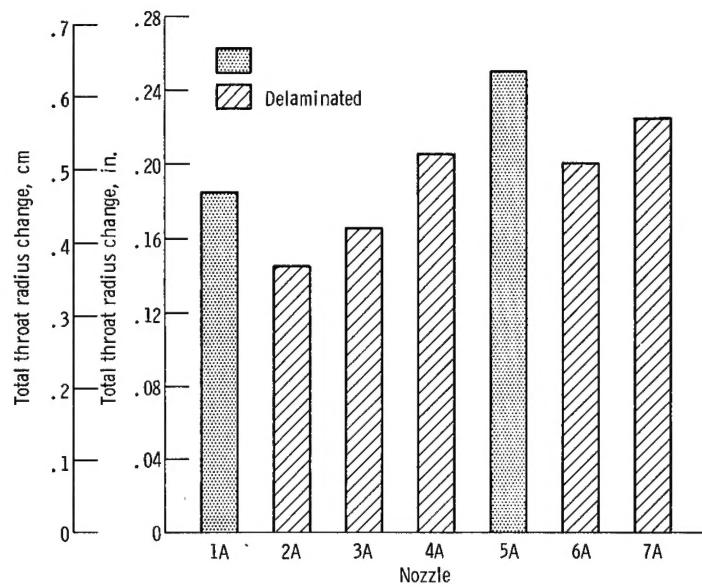
(a) Orientation, 30° centerline.

Figure 10(a) presents the erosion data for the 30° orientation of materials 1 through 7. Despite delamination upstream of the throat, which probably helped reduce throat erosion, the MX-2600(2A) material was superior in erosion resistance to all other materials tested at this fabric orientation. Nozzles 1A (MX-89) and 5A (MXS-141) were the only ones that did not delaminate during the firing. All other materials delaminated during the firing as is indicated in figure 10(a). A 30° orientation of the fabric to the nozzle centerline cannot be used when the entrance half angle of the nozzle is 30° or more. This results in a 0° orientation to the hot gas flow and is responsible for fabric delamination.

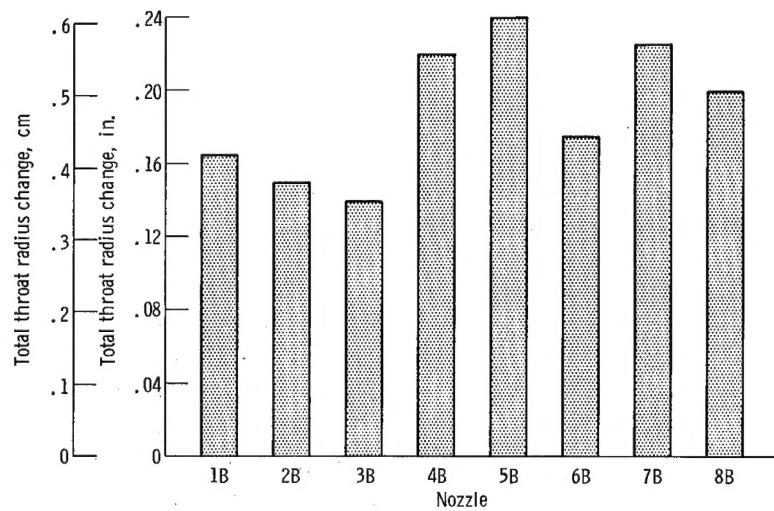
(b) Orientation 60° centerline.

The erosion data for the materials laid up 60° to the nozzle centerline is presented in figure 10(b). Nozzles 2B and 3B (MX-2600 and MX-19) had the greatest resistance to erosion. The least erosion resistant material, 5B (MX-141), was similar in construction to 3B, except for a small percentage of chromium salts added to the fabric of 5B. The wide difference in erosion resistance was not expected for these two materials, nor was 3 material expected to be superior to 5 (ref. 1). The 60° orientation provided erosion resistance equal to, or better than, the other fabric orientation for eight of the nine materials evaluated. The only exception was material 4 (MX-87) which was low in resin content (20 percent).

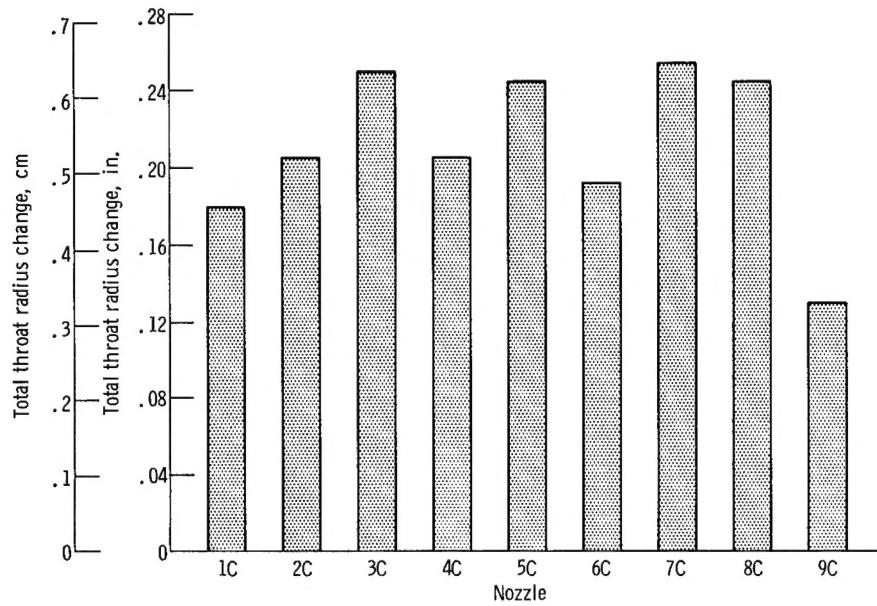
(c) Orientation, 90° centerline.

Figure 10(c) compares the erosion resistance of all the materials laid up at 90° to the nozzle centerline. Material 9C, quartz reinforced, was superior in erosion resistance to all other materials tested by a wide margin. For this orientation, the similar materials, 3C (MX-19) and 5C (MXS-141), were approximately equivalent in erosion resistance. The 90° orientation gave the best erosion resistance for material 4 (MX-87). It appears that to provide adequate cooling for low resin content ablatives, the decomposed resin gases must be injected most efficiently into the boundary layer. The 90° orientation apparently allowed better utilization of the coolant gases than the 60° orientation for the low resin content ablative material. The lowest cost material, 2C (MX-2600), was also reasonably resistant to erosion.

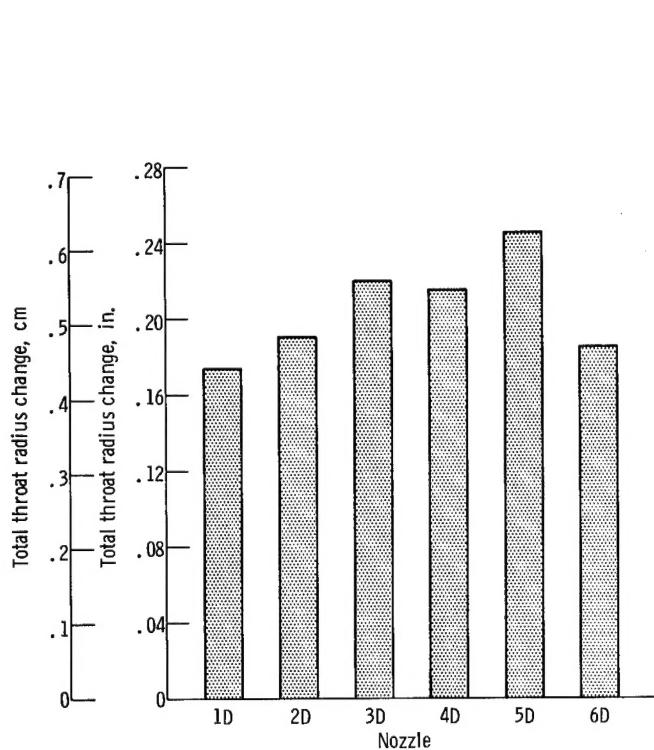
(d) Orientation, 1/2 by 1/2 square.

Materials 1D (MX-89) and 2D (MX-2600) had the best resistance to erosion when compared to other materials laid up from 1/2- by 1/2-inch (1.27- by 1.27-cm) squares (see fig. 10(d)). The molding compounds were similar in erosion resistance to the 90° layup (compare figs. 10(c) and (d)). The molded squares actually approach a 90° to the centerline orientation (see fig. 6(d)) but are significantly less expensive than the tape layups.

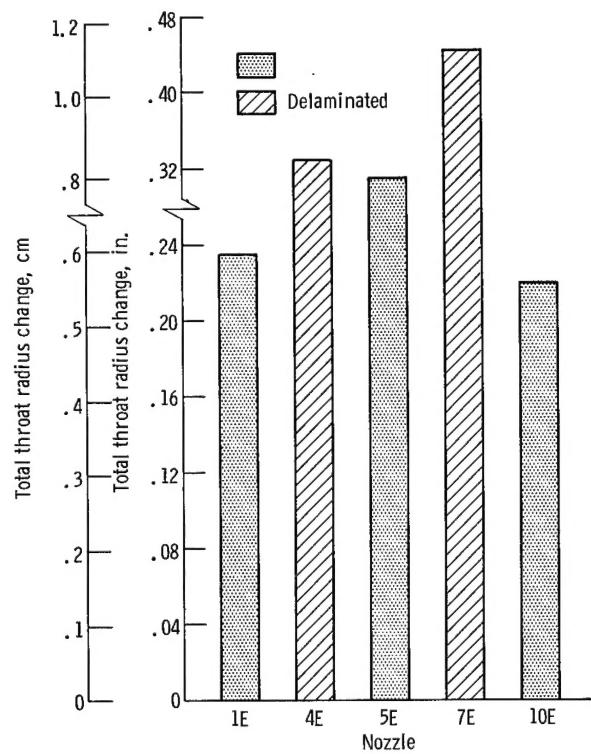
(e) Orientation, rosette.

All of the materials tested in the rosette configuration eroded at a very high rate. Figure 10(e) shows material 10E (quartz reinforcement) as being superior to all of the other materials tested with a rosette configuration.

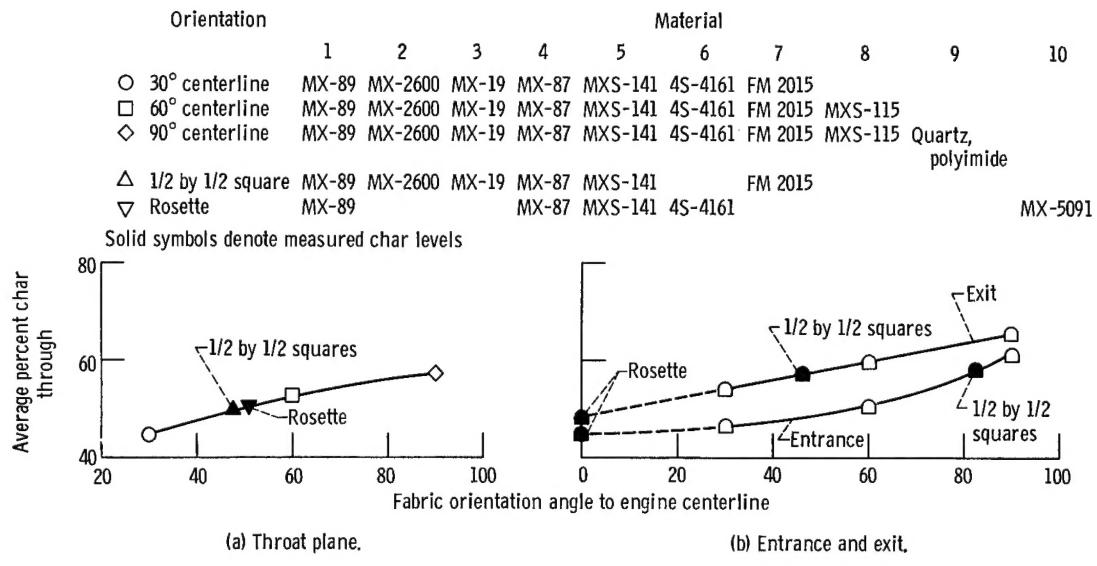
Figure 11. - Ablative char against fabric angle.

The average percent char-through of all nozzles tested has been compared with respect to the fabric orientation angle to the engine centerline. Figure 11(a) shows a curve of the average char-through at the throat plane and figure 11(b) shows the char at both the entrance and exit planes. All three curves have the same general shape. On each curve, the 1/2- by 1/2-inch (1.27- by 1.27-cm) squares and the rosette layup are entered at the measured char level. The 1/2- by 1/2-inch (1.27- by 1.27-cm) squares and the rosette layup appear to be equivalent in percent char-through to a 50° fabric orientation at the throat plane. The rosette layup for both the entrance and exit planes of the nozzle had the lowest percent char-through and is equivalent to a 0° fabric orientation if fabric orientation curves are extrapolated.

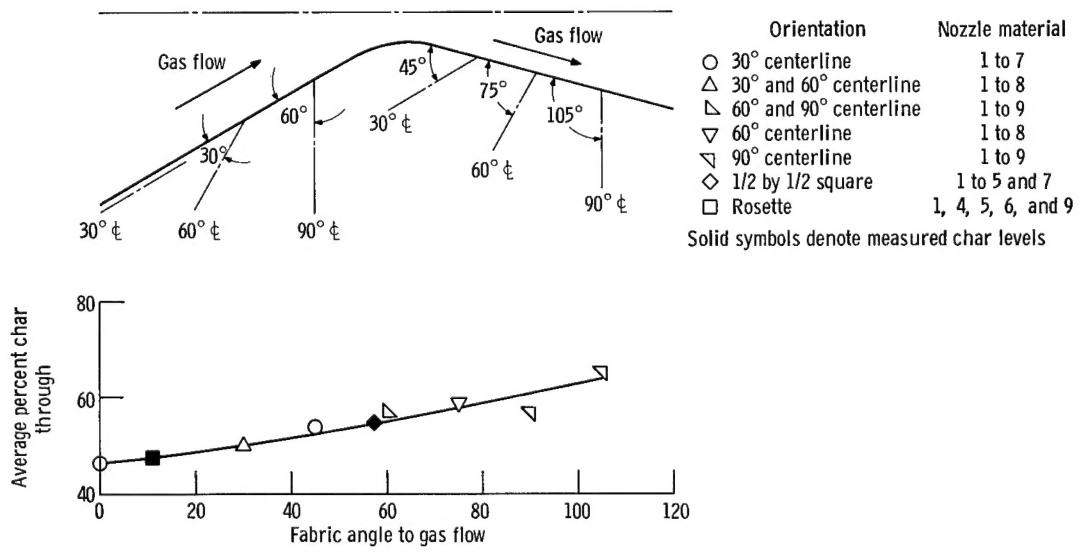
Figure 12. - Ablative char against fabric angle to gas flow.

Since the effective fabric angle differs greatly from entrance to exit, it would seem to indicate that the primary method of charring at constant heat flux might be related to the length of the fabric heat path. The length of the heat path is determined by the angle formed between the internal surface contour of the nozzle and the fabric orientation regardless of the nozzle plane location. The average percent char can then be considered as a function of the fabric orientation angle to the gas flow as in figure 12. A sketch of the nozzle contour is included for clarity. The points shown are averages of all the available data. The curve suggests the desirability of maintaining a low angle of fabric orientation to the gas flow from a char standpoint. Combining minimum char orientation with erosion resistant orientation in the required areas of the nozzle should result in minimum engine weight. The rosette layup as fabricated acted as a 0° to gas flow orientation because the plies were laid up longitudinally and were radially compressed to effect an almost parallel layup to the gas flow.
